TASK MEMORANDUM

DATE: November 4, 2023

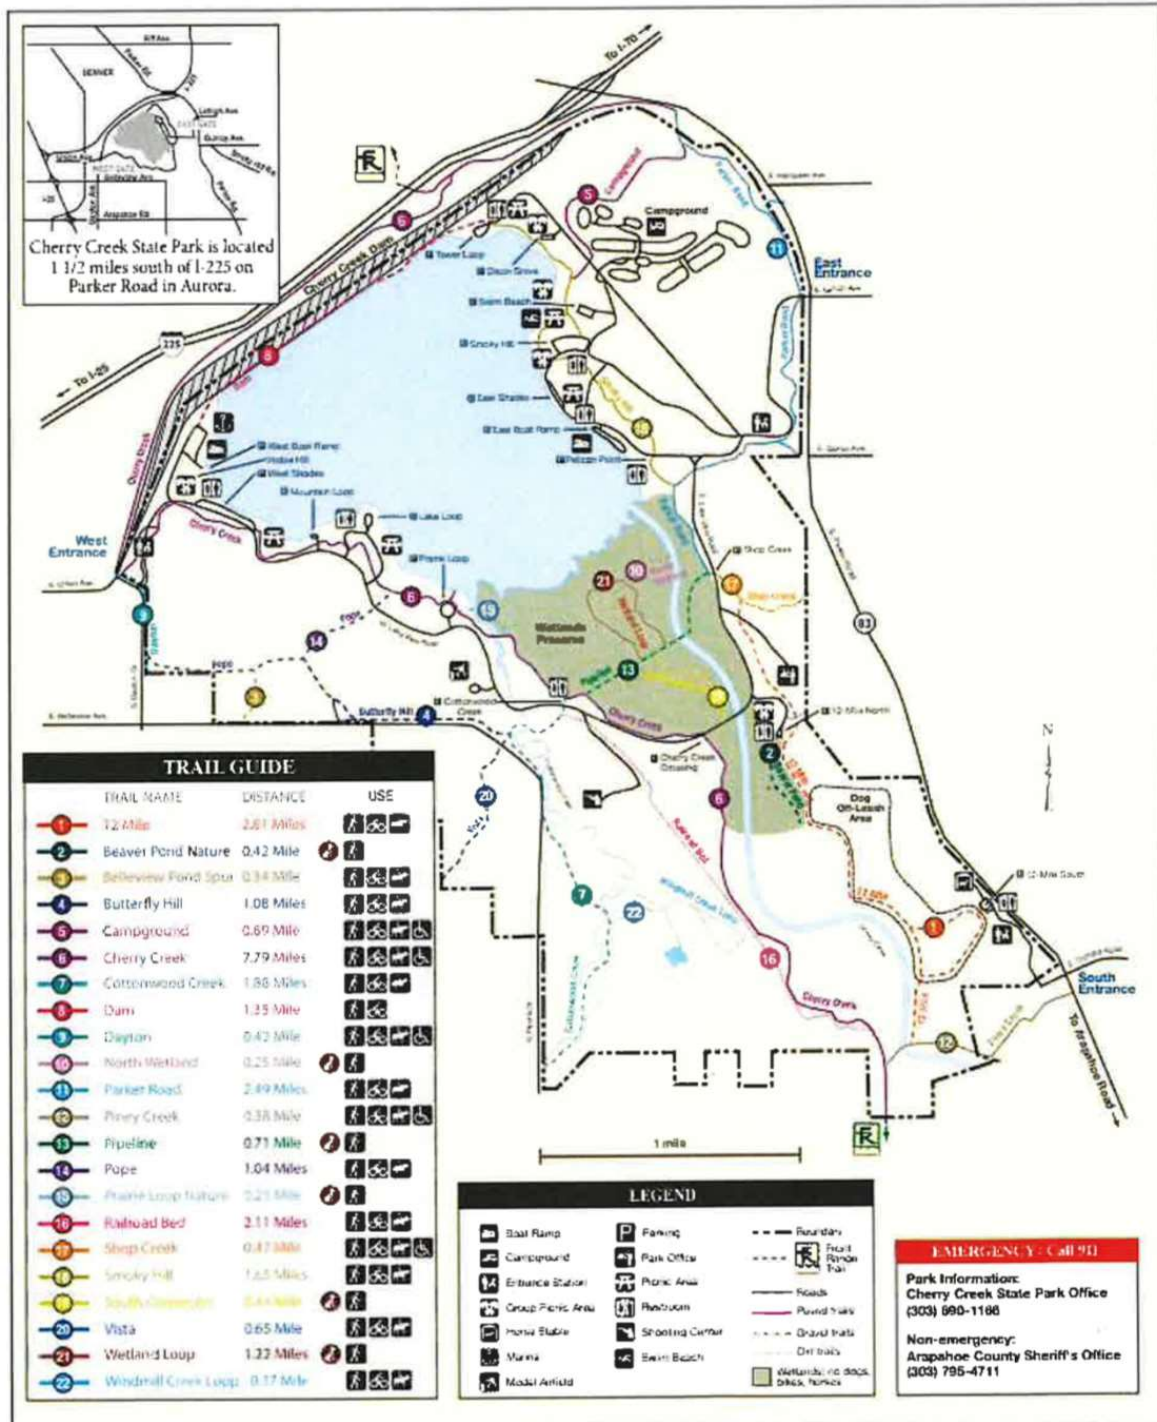
All the PRFs were observed. The field observation was conducted on September 26, 27, 28, 29 and October 3rd. Parks officials did not accompany the inspections as they were too busy and requested a walkthrough later in the fall.

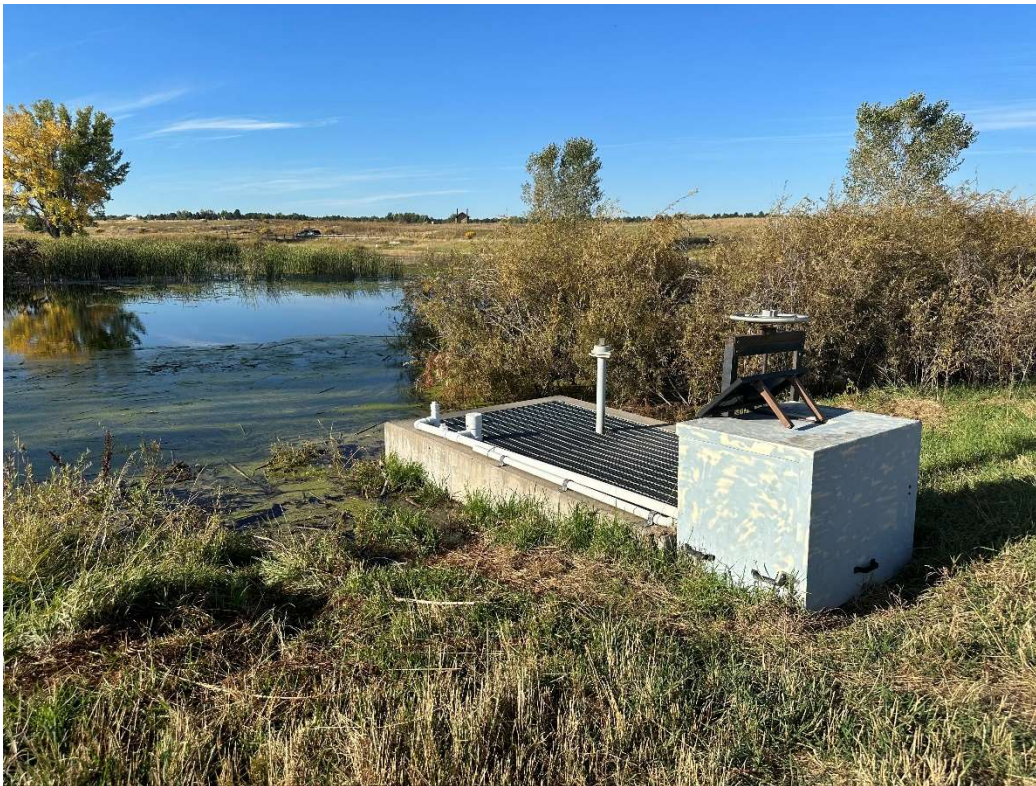
Cottonwood Wetlands: Some aquatic vegetation and cattail debris was observed on the surface of the water. The water level was down significantly from the month before, but still high enough that water was overflowing the access trail. The educational signs were in good shape and did not appear to have been damaged in any way by the storm. Compaction from last year's harvesting activities was observed, but otherwise, there was no plant stress observed from this year's floods. Some compaction was noticed from this year's harvesting activities. Maintenance for consideration is decompaction and reseeded of the area along the trail and cleaning out of the outlet structure grate.

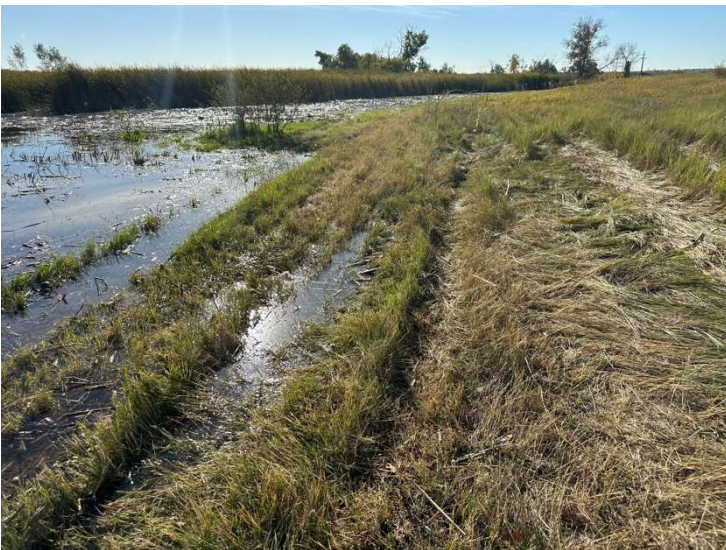
Compaction and wheel-tracking from this year's harvesting activities

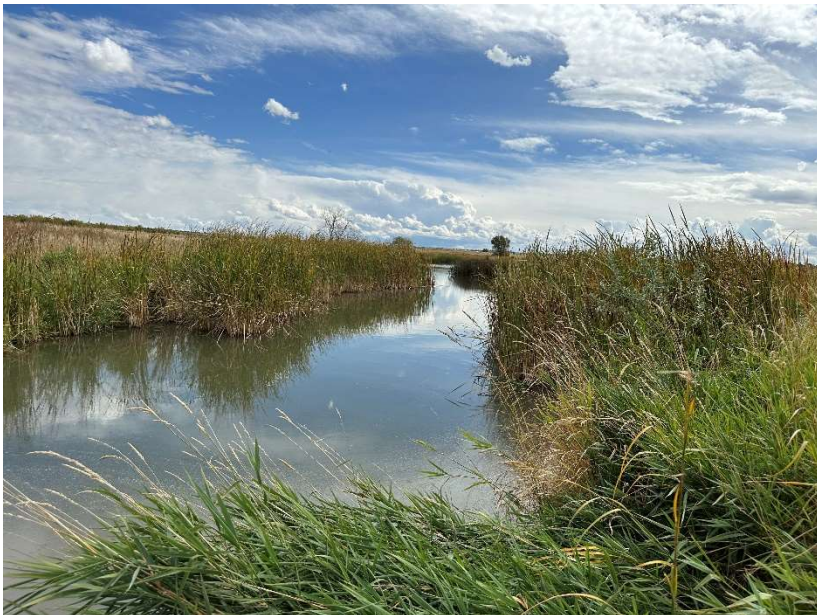
specifically identified, however, monitoring and coordination with CCSP staff regarding noxious weeds is recommended. Monitoring of the wheel-tracking should be done next spring to determine to what extent any decompaction and re-seeding might be required. Also, CCSP will need to do some significant trail maintenance.

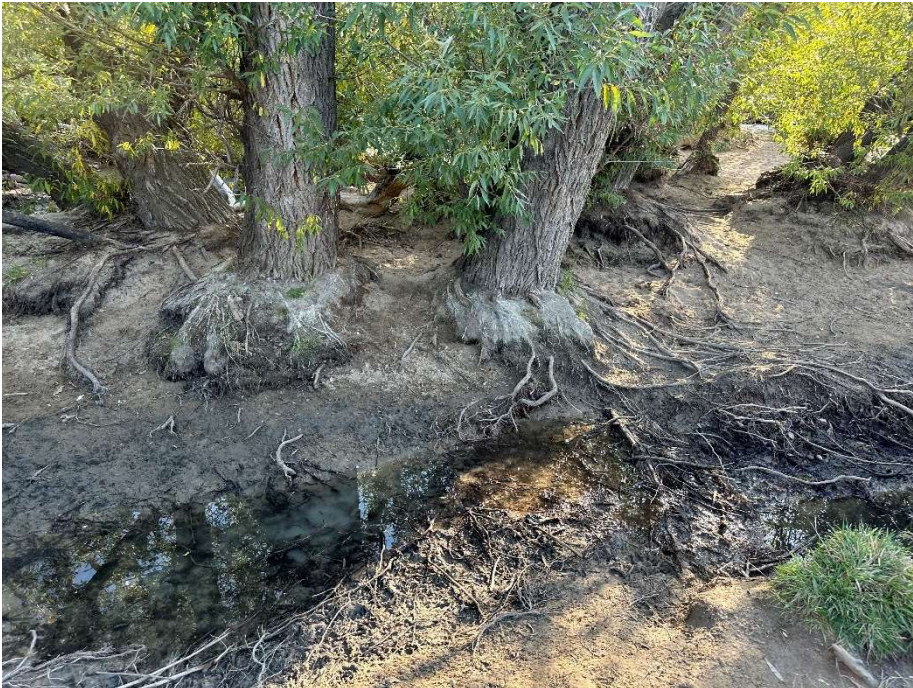
Tree islands caused by extreme bed scour

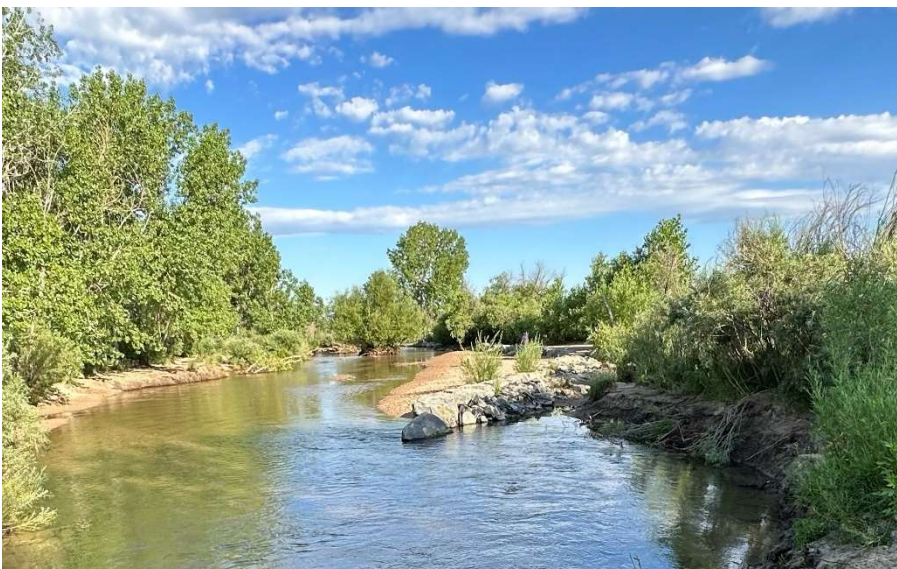
Beginning of beach area- severe erosion behind the boulder edging and of the beach itself, starting a second channel behind the boulder edging

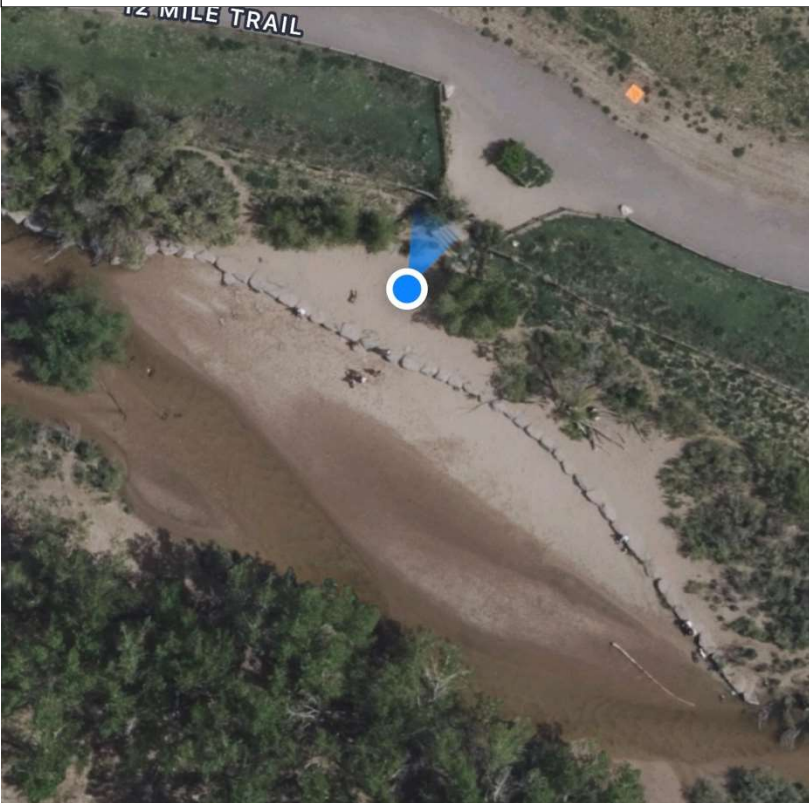
Satellite photo of DOLA beach showing how the creek doesn't follow the path that was used for the boulder edging design.

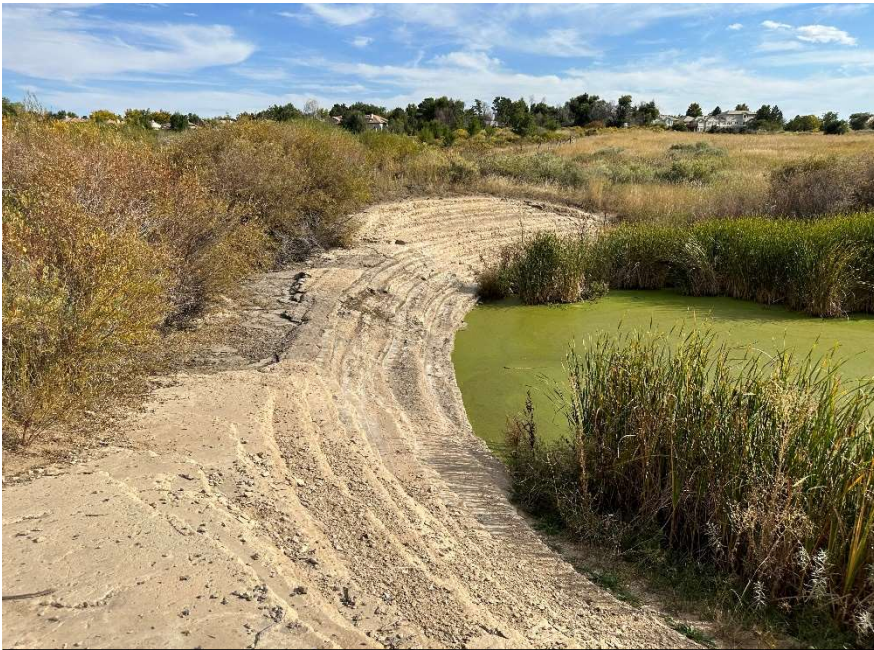
recommended for maintenance and repair. The information signs were in good repair and not in any need of attention.

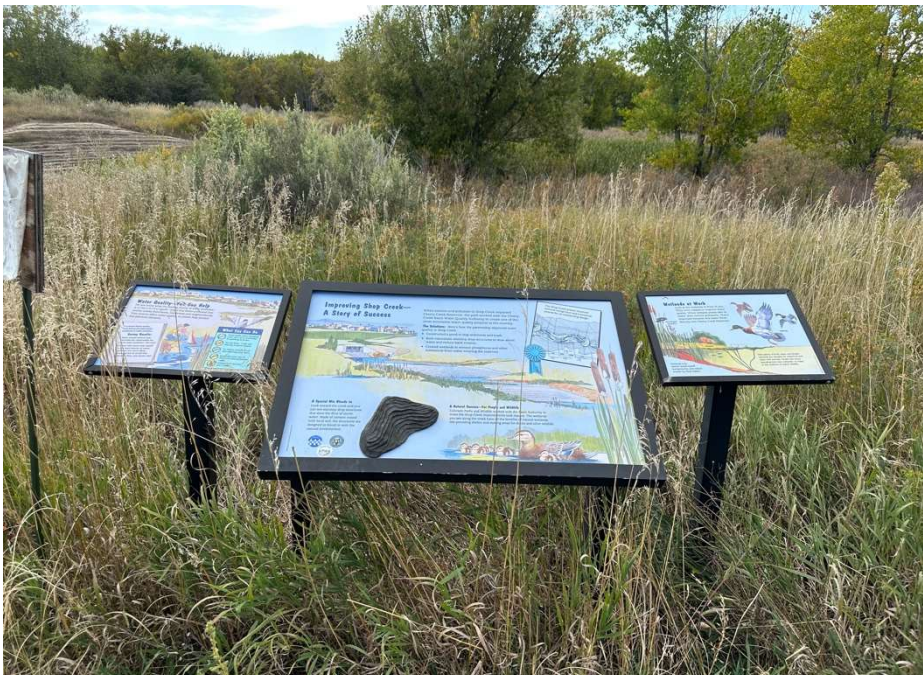
Shop Creek Informational Sign

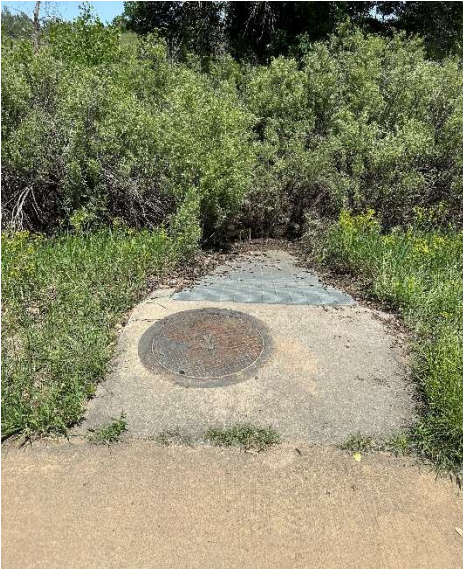
Debris clogging of the outlet structure

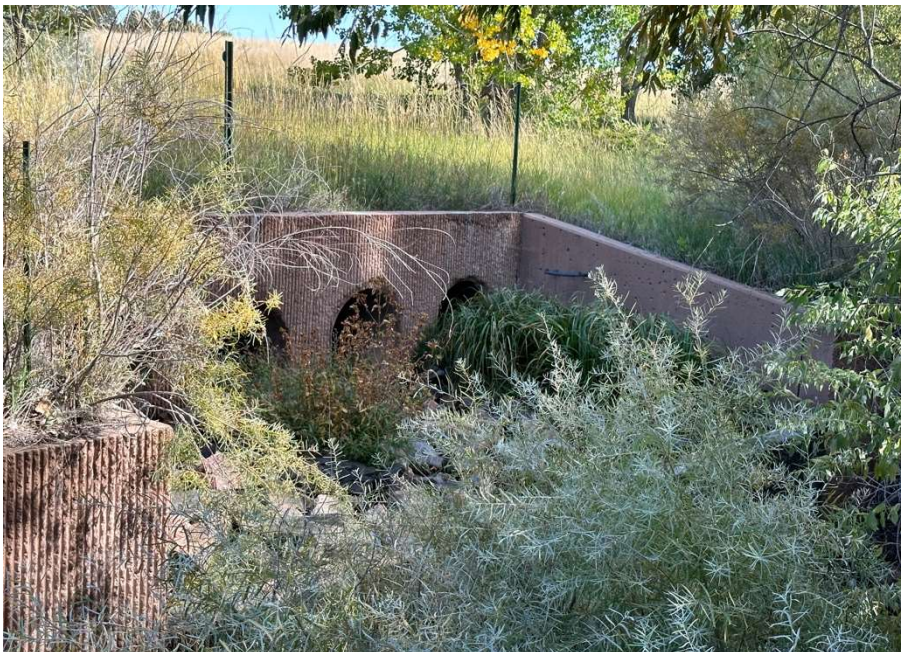
Outlet at Lakeview Dr. becoming clogged with plants.

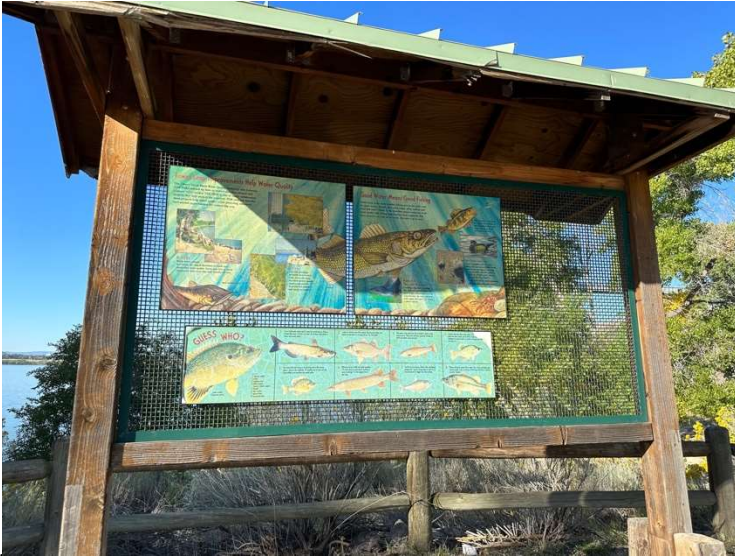
Informational sign in good condition

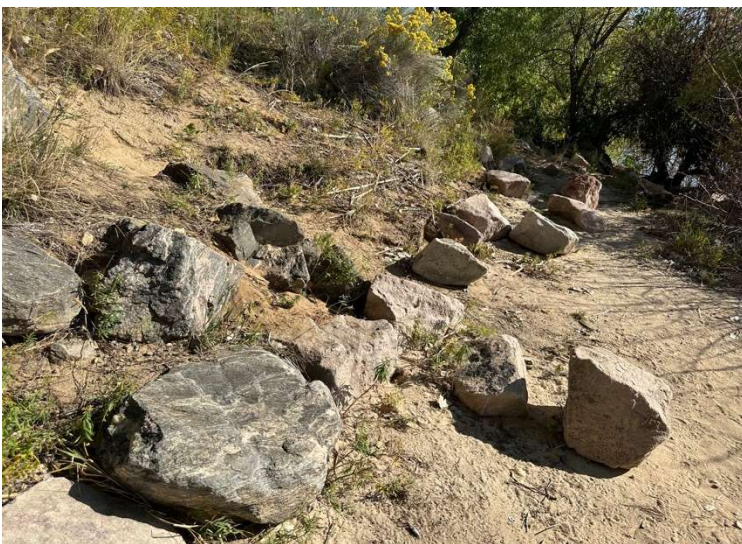
Human-displaced boulders

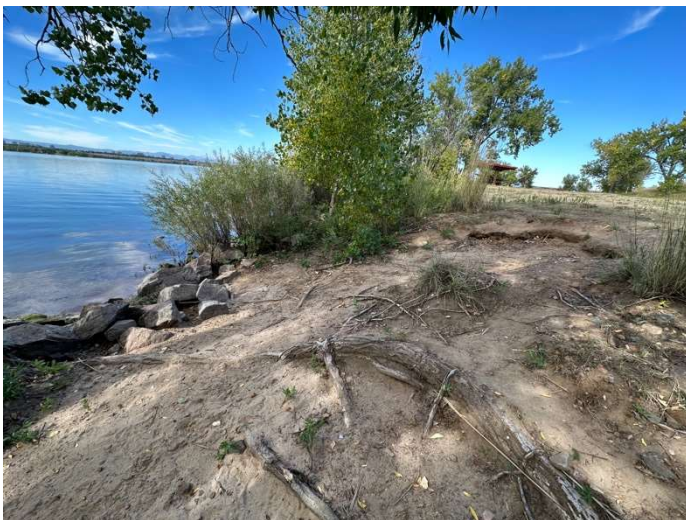
Flood caused above stabilization level erosion

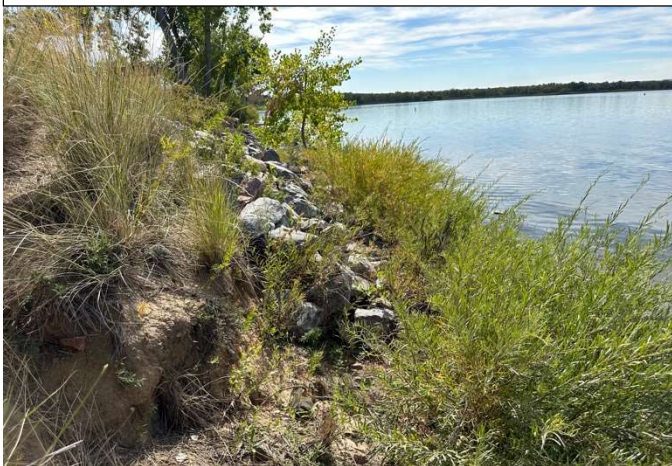
Bank erosion above operating level caused by flood not previously riprapped.

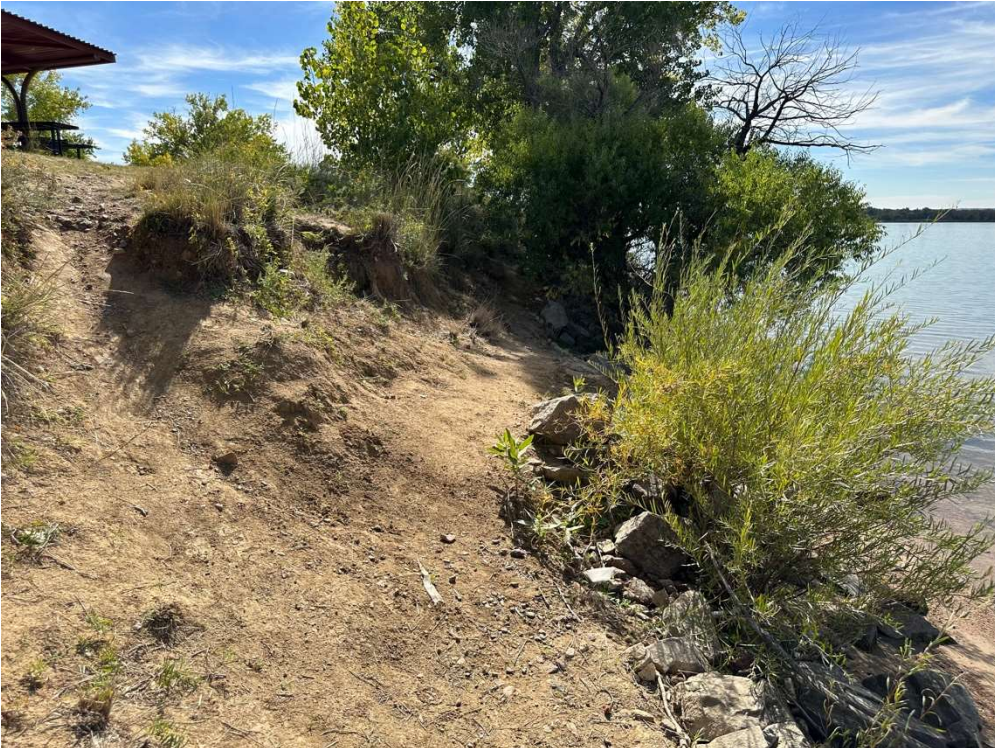
Above flood level bank erosion

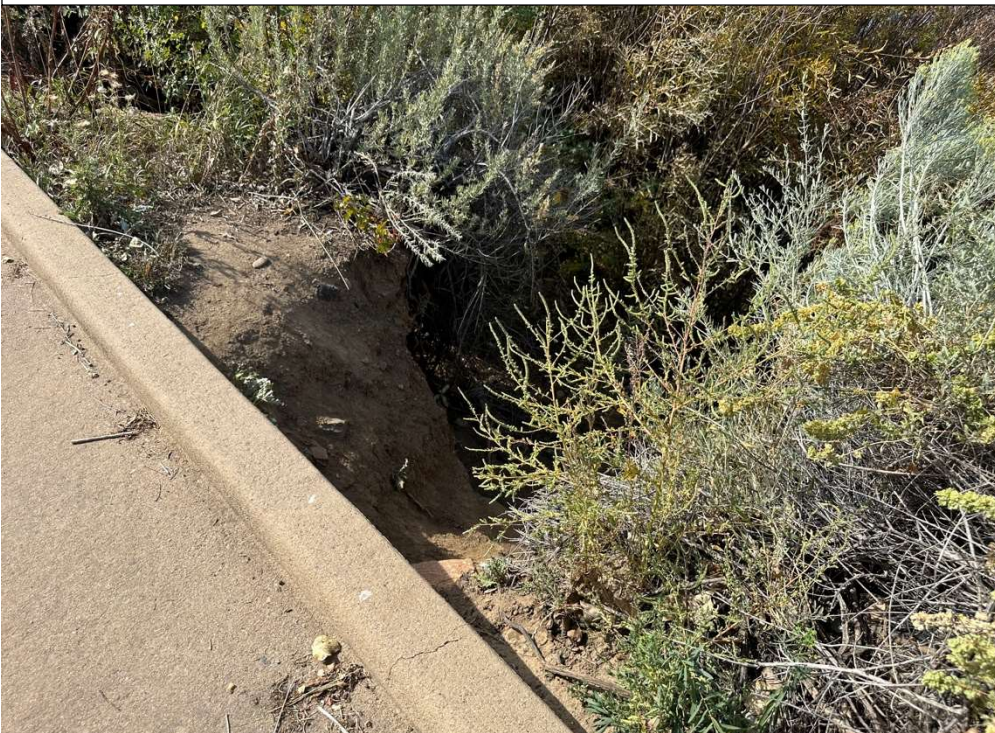
Vertical bank erosion caused by flood overtopping curb and fisherman access.

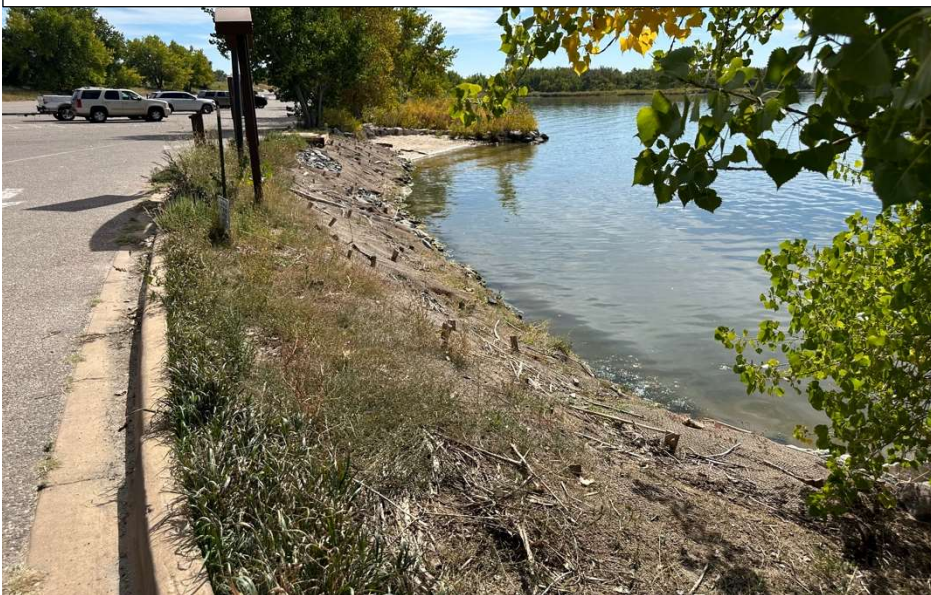
Reseed and mulch 2022 maintenance project.

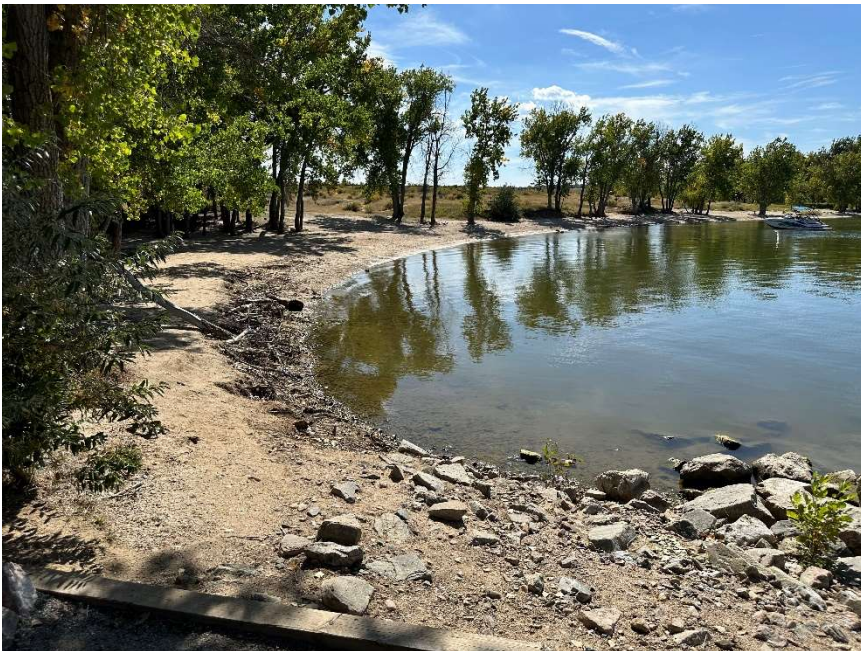
100-foot eroding shoreline that will be stabilized by current maintenance project.

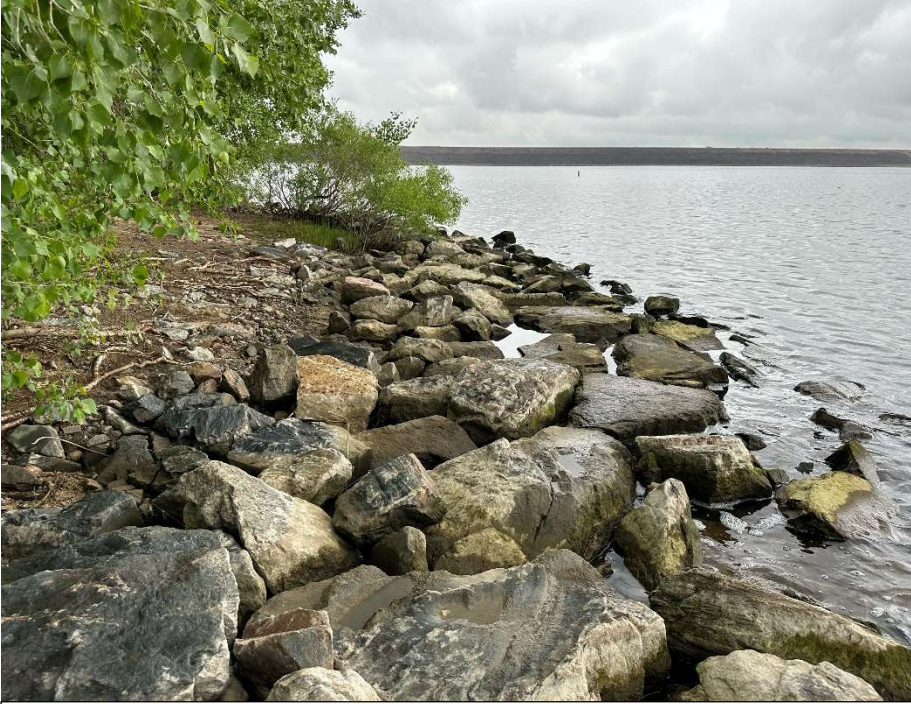
Current condition of shoreline stabilization

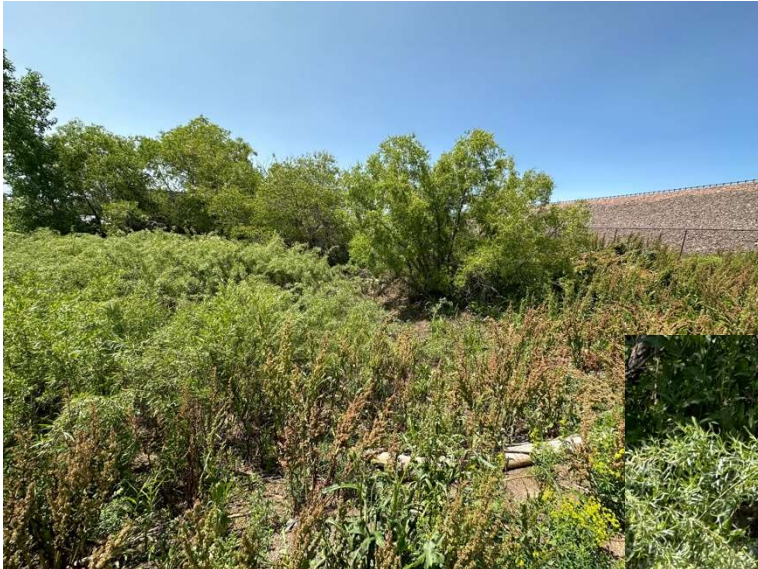
Outlet clogged with plant material
